PROBLEMS OF LANDSCAPE ARCHITECTURE
IN
THE NATIONAL FORESTS

REPORT TO U. S. FORESTER'S OFFICE
ON
TRIP OF INSPECTION THROUGH SOME OF THE NATIONAL FOREST AREAS
IN
REGIONS 2, 4, 6 AND 1

BY
A. D. TAYLOR
CONSULTING LANDSCAPE ARCHITECT
SEPTEMBER 1935

(July 26, 1935 through August 22, 1935)

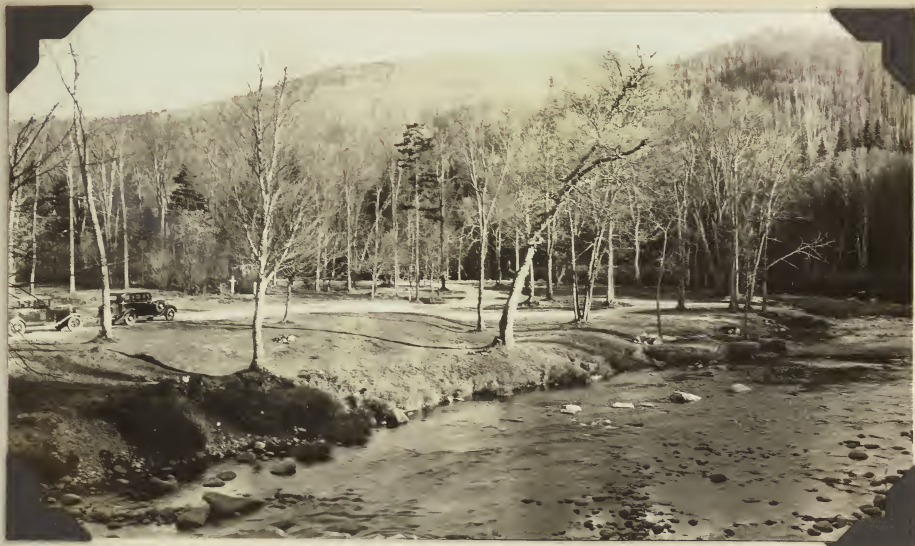
White Mountain National Forest - Zealand Forest Camp

General view showing the type of camp ground area which is extremely popular in this Region. The camps are erected along the shore of the river. Note the piles of rocks which indicate the locations of the fireplaces. The road layout in this camp ground is being revised.

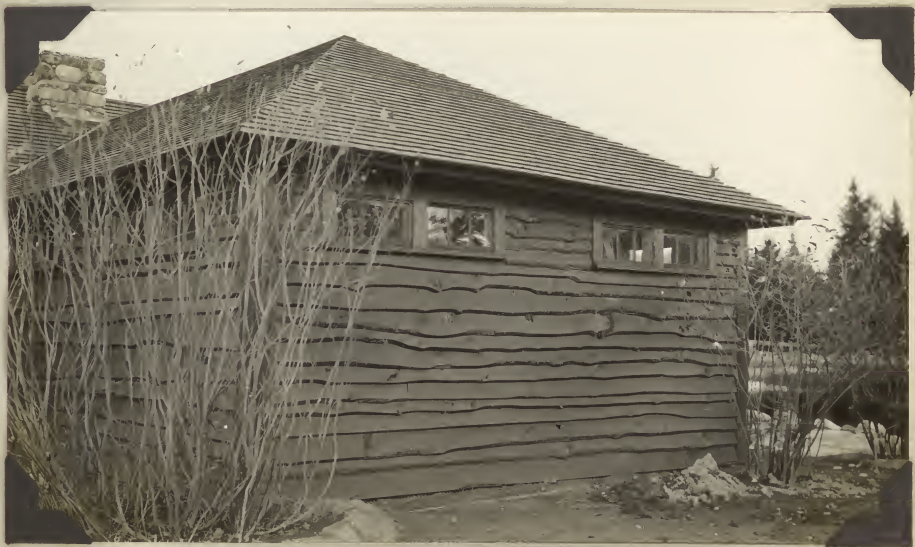
Moose Brook State Park

Detail view of one side of the bath house, showing the very informal and most interesting method of covering the side of this building. The effect is very naturalistic and pleasing.

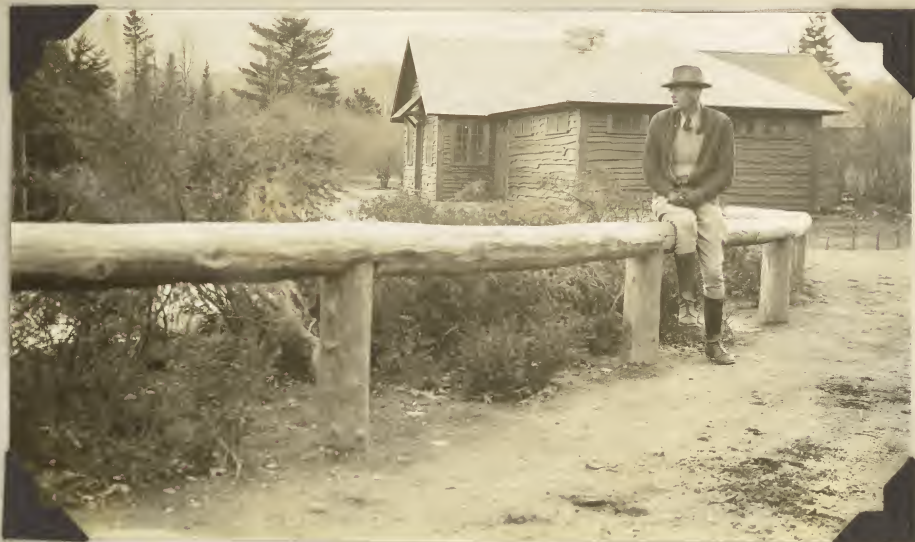
Detail view showing the guard rail which defines the sides of the more important roads through this camp ground area.

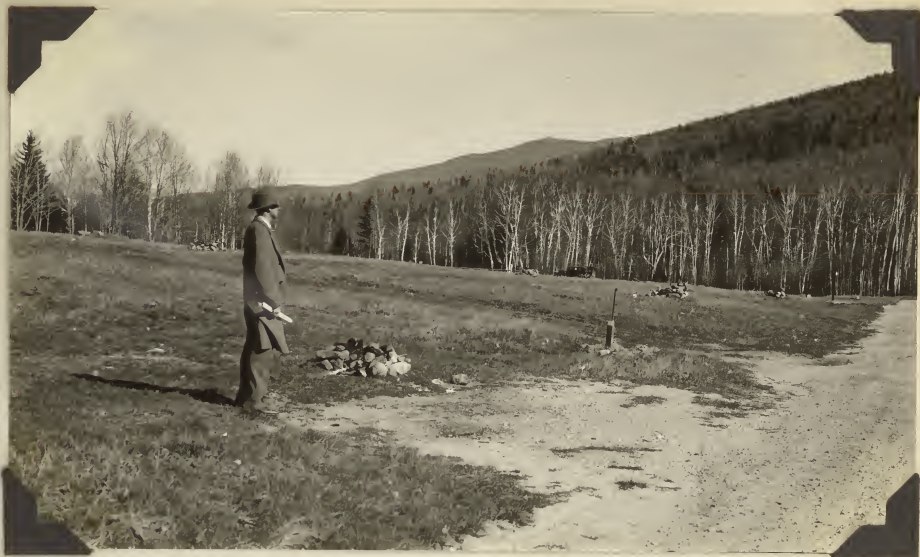
White Mountain National Forest - Dolly Copp Forest Camp

General view showing the type of open area which is so much in demand for camping purposes in the White Mountains. The piles of stone indicate some of the locations in which fireplaces were constructed.

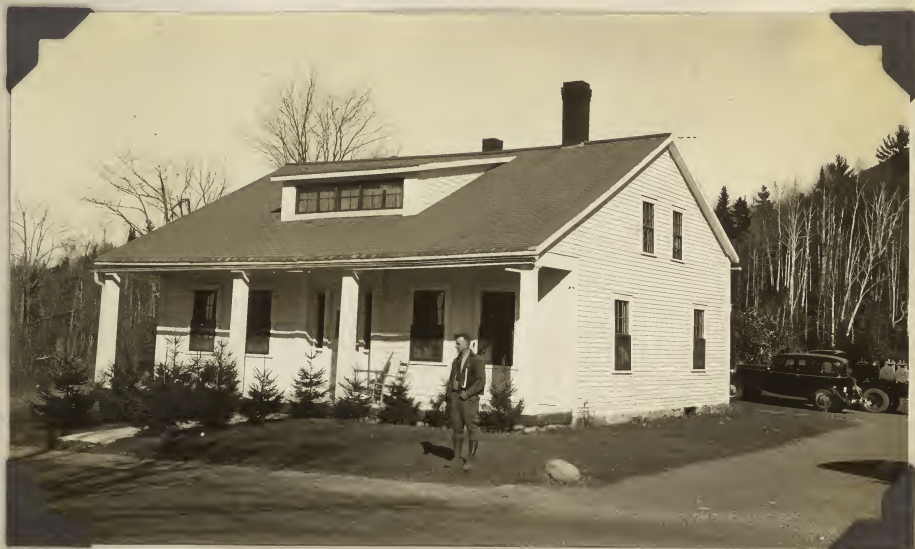
White Mountain Ranger Station - Dolly Copp Forest Camp

General view of Peabody Ranger Station residence. Careful study should be devoted to the solution of the planting problems in connection with ranger station residences and other buildings. These spruce trees will rapidly outgrow their present location and will become a liability instead of an asset in this composition.

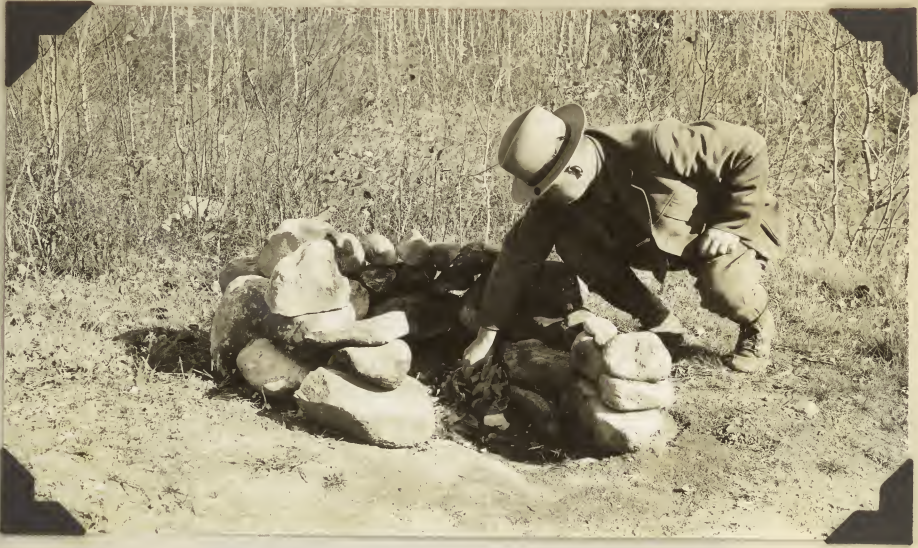
White Mountain National Forest - Dolly Copp Forest Camp

Detail view of a typical fireplace generally used in this camp ground and constructed by the campers.

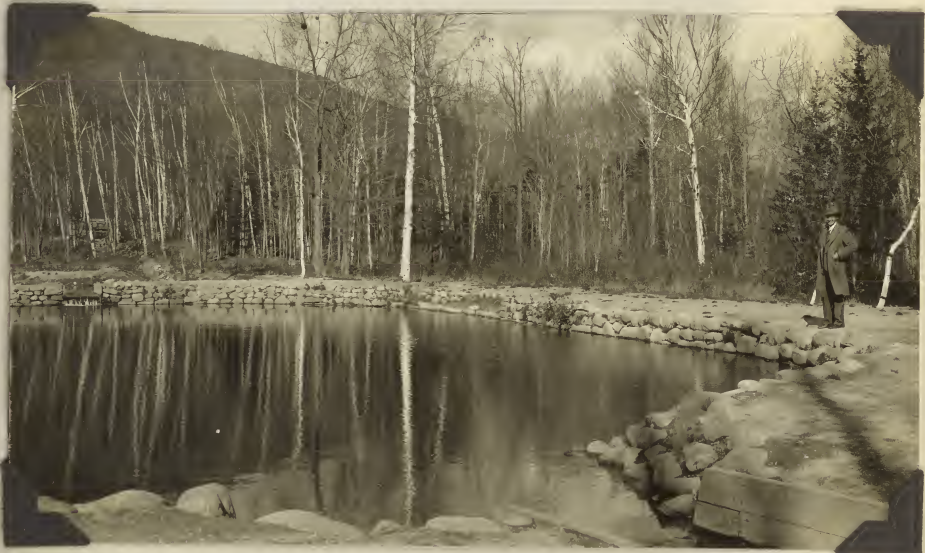
White Mountain National Forest - Dolly Copp Forest Camp

A bathing pool which does not have a pleasing outline nor an attractive type of construction. This area does not blend naturally into the surrounding forest landscape.

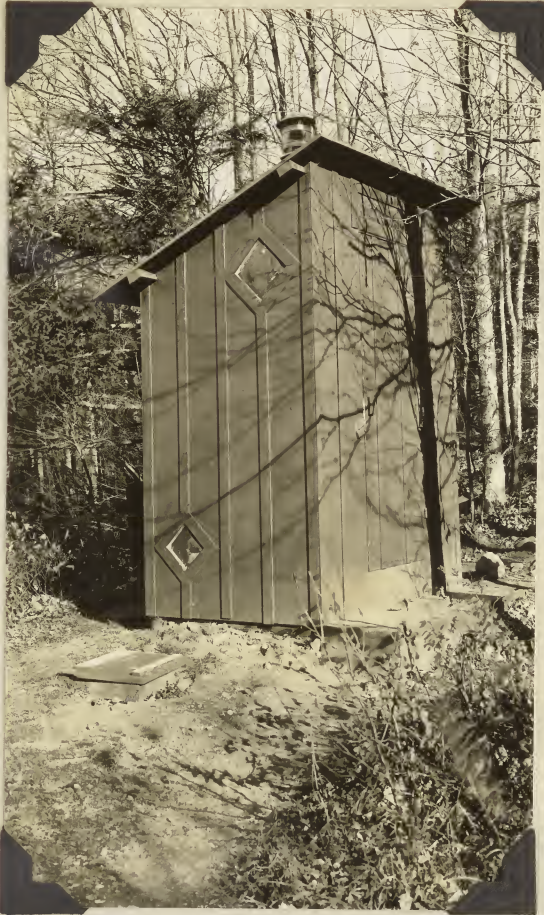
White Mountain National Forest Camp
Dolly Copp Forest Camp

Detail view of the type of toilet building now in general use in these forest camps. More study should be devoted to the problem of developing a type of toilet building which fits much more appropriately into the forest surroundings.

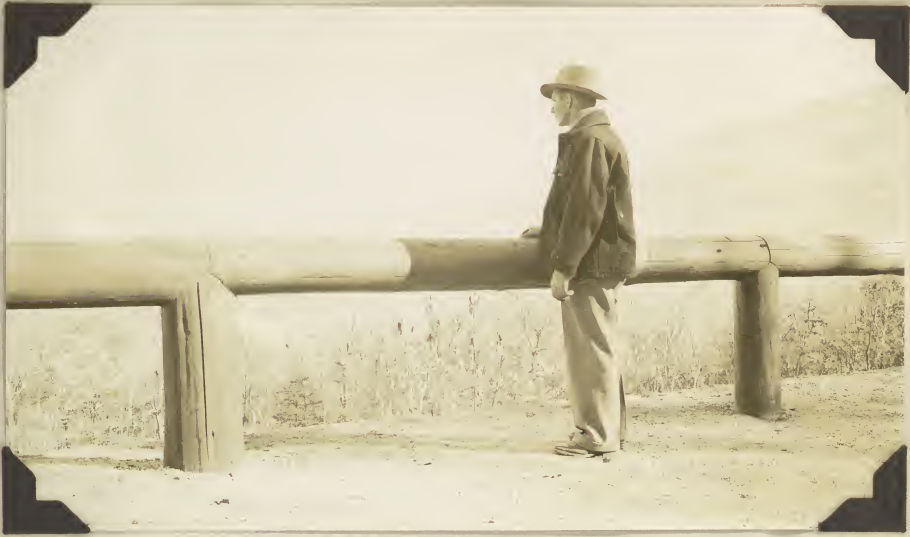
White Mountain National Forest - Bear Notch Forest Highway
"Second Vista"

Note the detailed construction of the interesting guard rail which has been constructed at this overlook point. The guard rail might have been at least six inches lower.

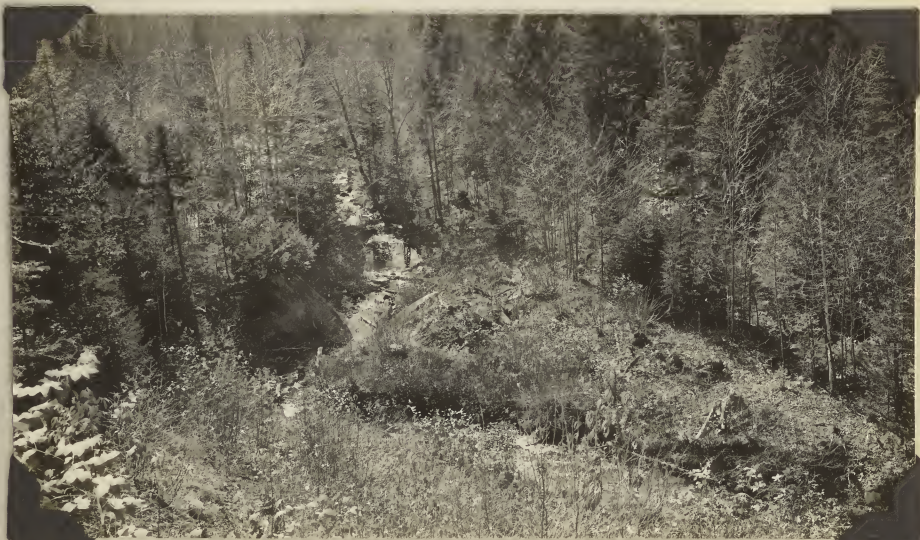
312254

White Mountain National Forest - Bear Notch Forest Highway

Detail photograph showing a "triangular" clearing made for the purpose of showing the attractive stream in the foreground of the distant view. Unfortunately, this clearing has not been carefully done and presents a rather artificial and unnatural appearance.

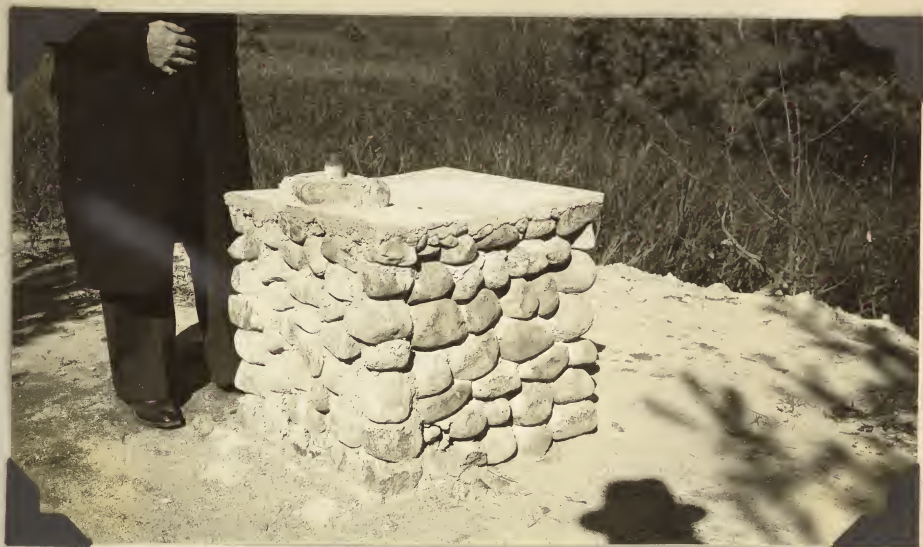
White Mountain National Forest - Passaconway Forest Camp

Detail of "pump" feature, with the pump removed for the winter. In constructing such features, careful consideration should be given to the texture of the stone work, which in this instance, is deeply "pointed" and does not produce the most pleasing effect.

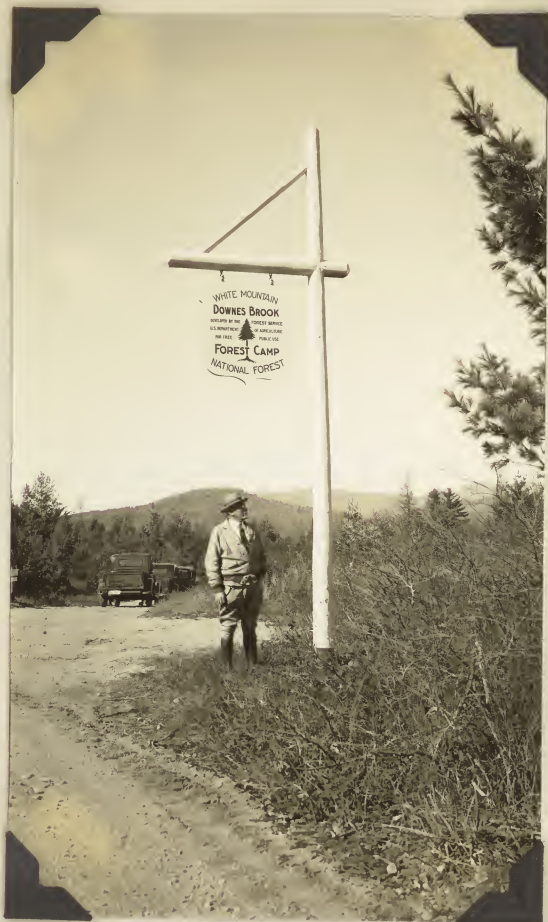
312258

White Mountain National Forest
Passaconway Forest Camp
 (Also known as Downes Brook Forest Camp)

Detail photograph of sign which seems unnecessarily high. The design of these signs should be given further careful study in order to get a more pleasing proportion.

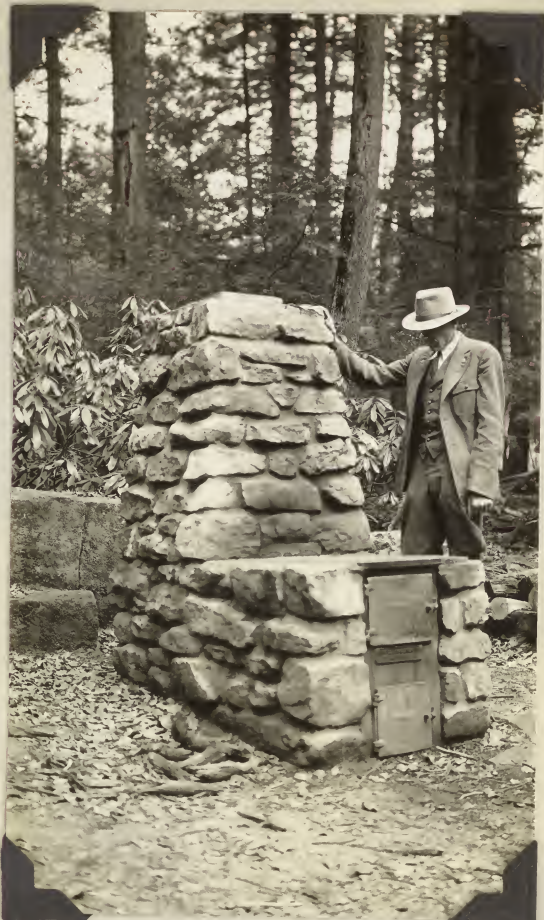
312271

Cook Forest Camp (In Pennsylvania)

General view of camp stove in which a patented iron frame is covered with stone work. In such camp stoves it is very desirable that the stone masonry work have a very informal texture and be well designed. This stone work could be greatly improved.

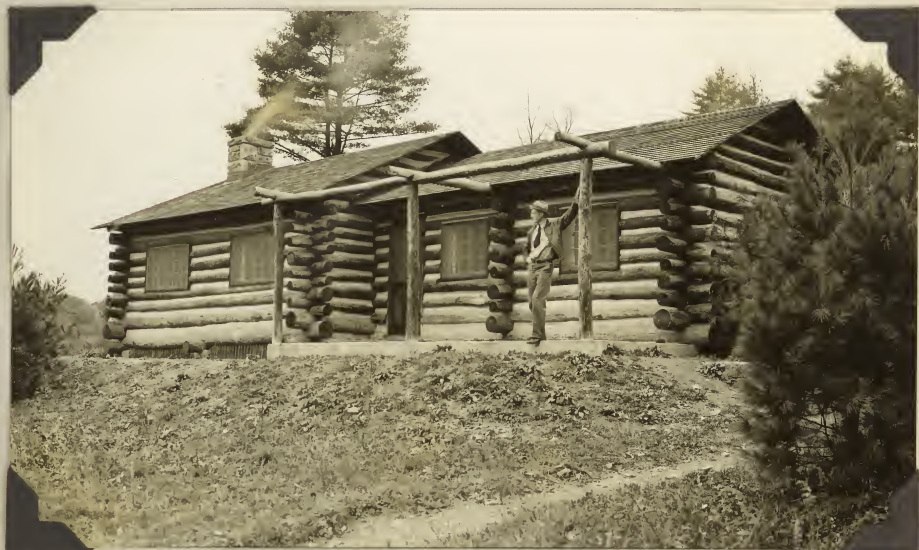
312274

Cook Forest Park - (In Pennsylvania)

General view of large special use cabin. These cabins are constructed to be rented by the State Park Agency.

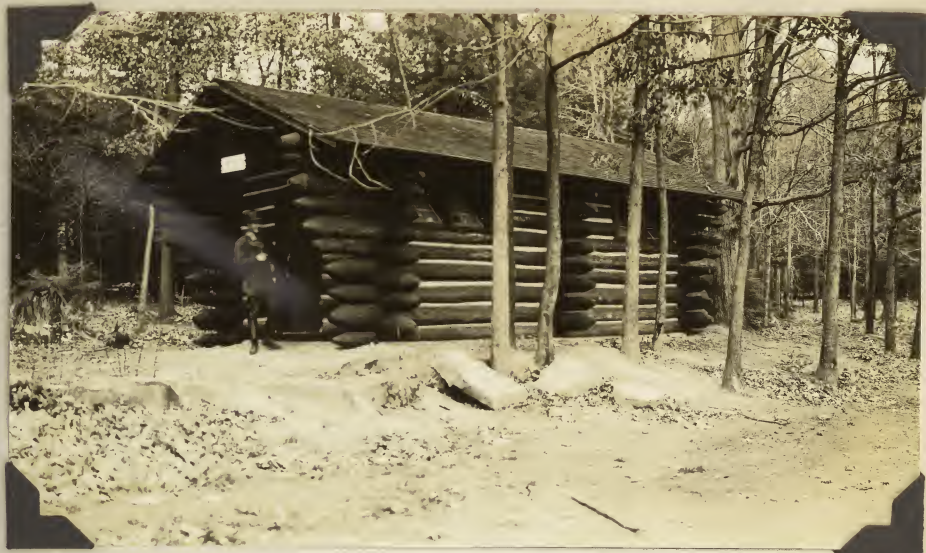
312275

Cook Forest Park - (In Pennsylvania)

General view of toilet building. This structure has an informal character; but it seems possible that the design might be improved by reducing the length of the projection of the logs at the corners, and also by reducing the dimensions of the roof accordingly.

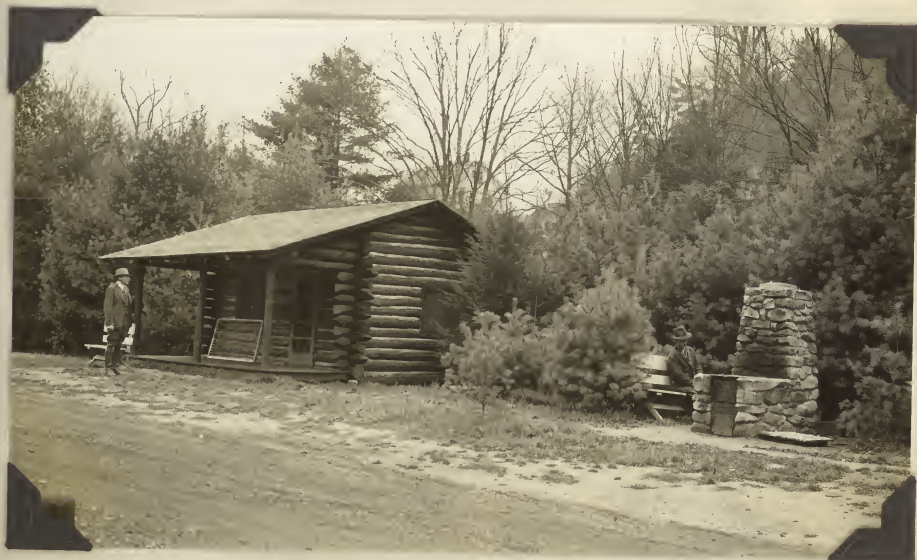
312277

Cook Forest Park - (In Pennsylvania)

General view of special use cabin and a rather excellently located camp stove.

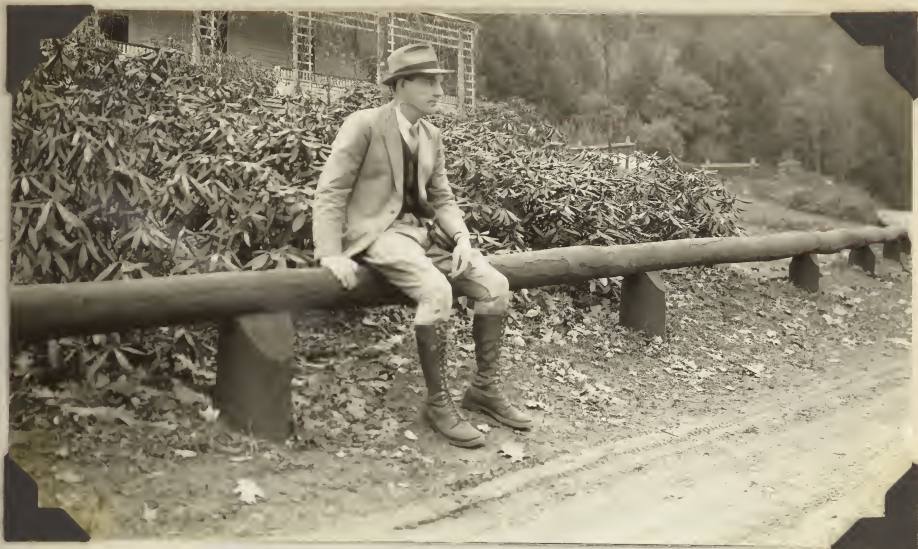
312280

Cook Forest Park - (In Pennsylvania)

Detail view showing construction of guard rail. Note the size of the posts and the method of bevelling the top of the posts to fit the rail.

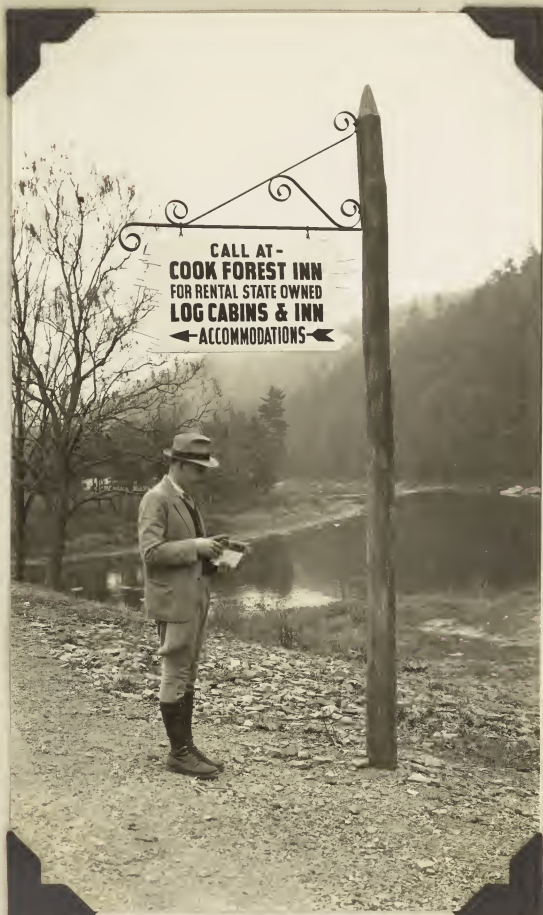
312281

Cook Forest Park (In Pennsylvania)

Detail of attractive and well proportioned sign. The use of iron work of this character would not seem to be appropriate for a National Forest Camp.

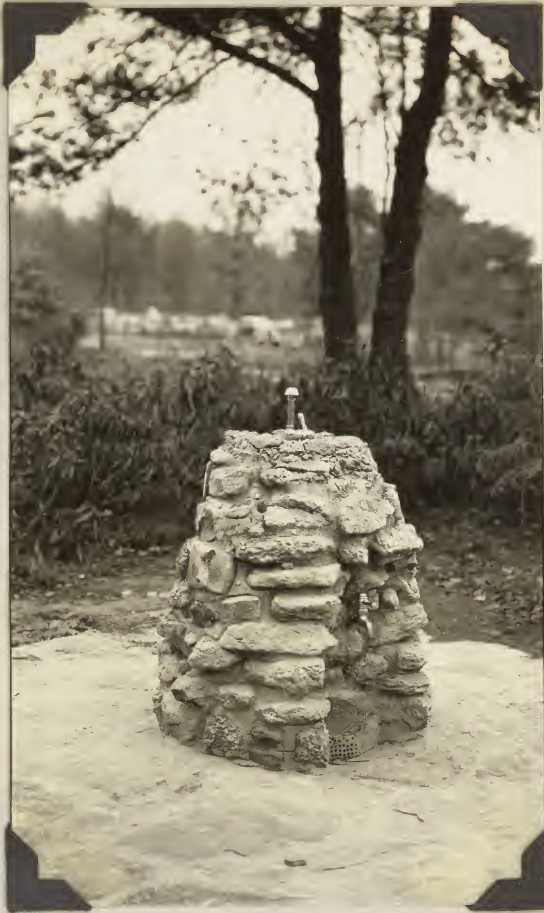
312282

Pennsylvania State Forest
Clear Creek Forest Camp

Detail of stone masonry drinking fountain and source of water supply for camp use. In fountains of this character, great care should be exercised in selecting a proper material and properly constructing the drain inlet at the base of the fountain.

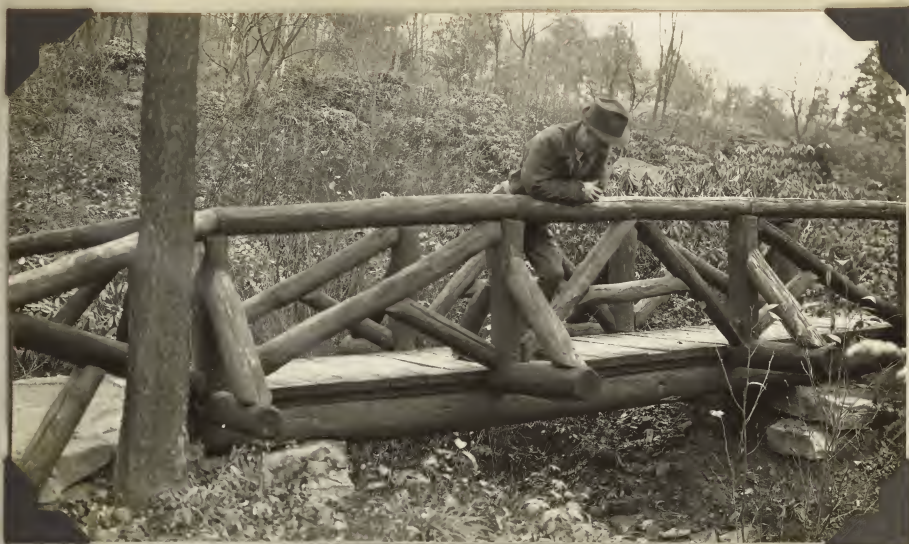
312 283

Pennsylvania State Forest - Clear Creek Forest Camp

Detail view of interesting log footbridge across the small stream.

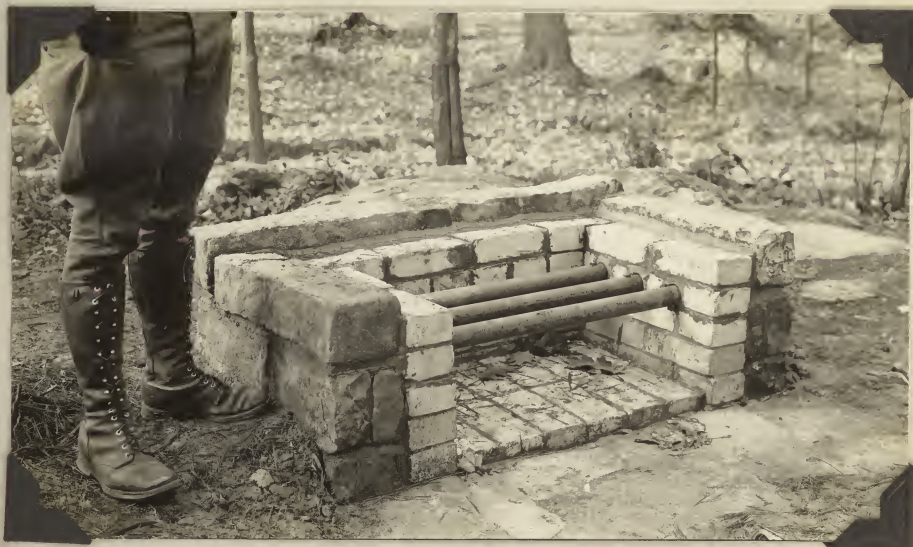
312 287

Allegheny National Forest - Sandstone Springs Forest Camp

Detail of fireplace. This type of fireplace does not seem to be entirely practical because of the shallow depth, the abnormal width and the wide space between the rods. This space is approximately six (6) inches and is too wide for general practical use.

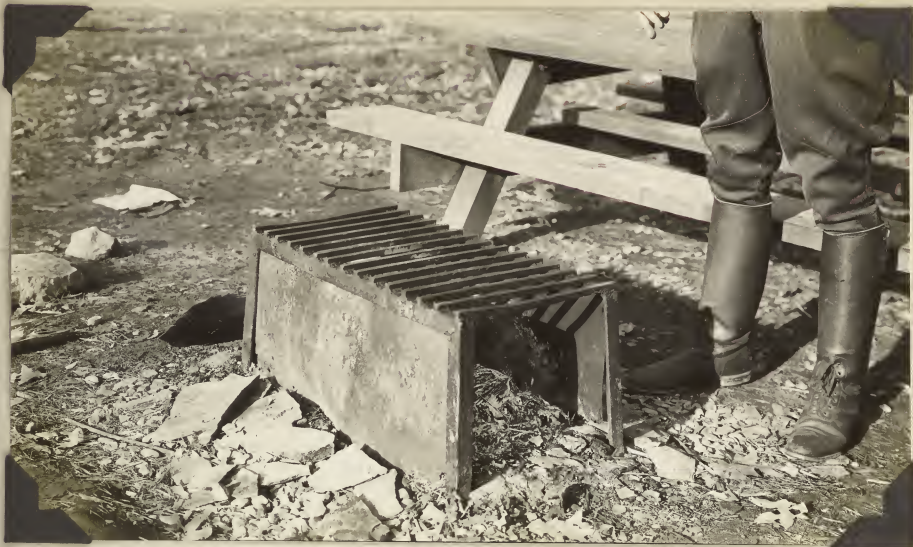
312288

Allegheny National Forest - Sandstone Springs Forest Camp

Detail of fireplace. Note the sheet iron which protects the sides.

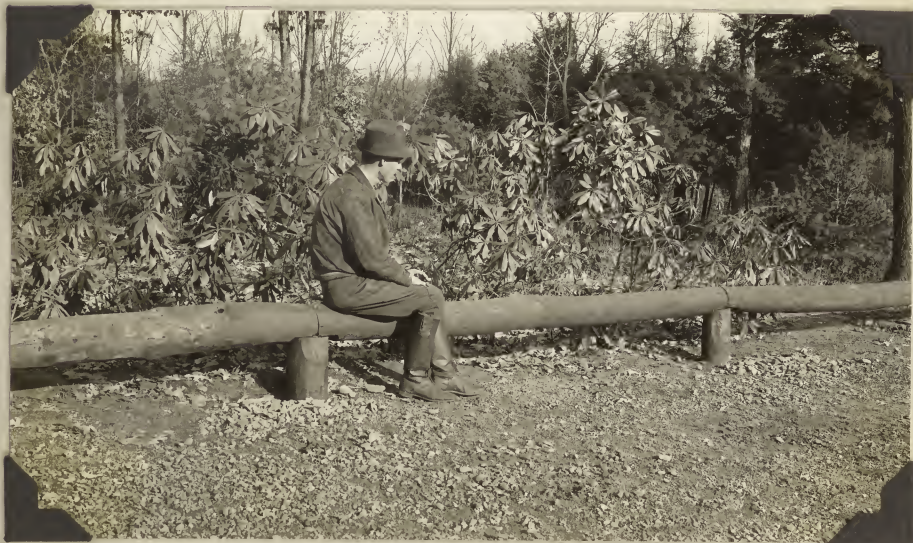
312290

Allegheny National Forest - Sandstone Springs Forest Camp

Detail of guard rail surrounding the parking space.

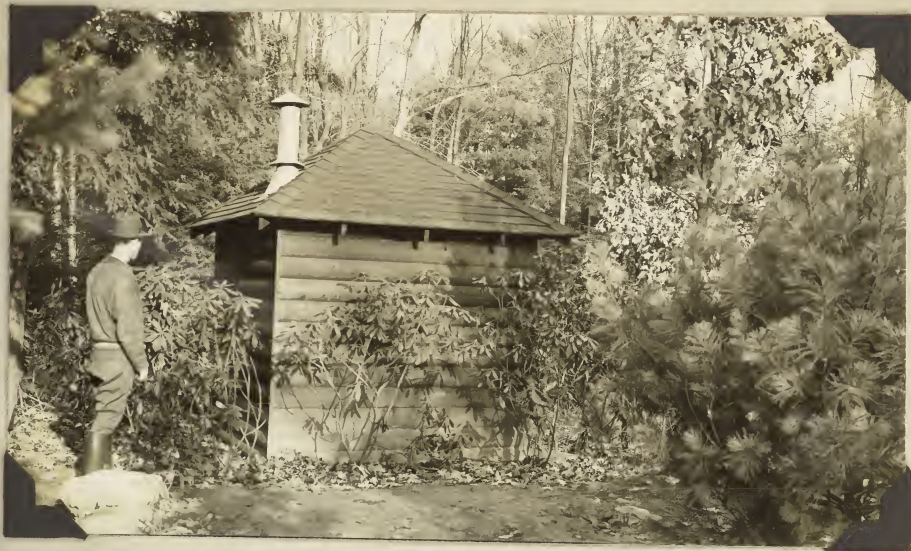
312291

Allegheny National Forest - Sandstone Springs Forest Camp

Detail view of toilet building which is well located and well designed. The galvanized chimney should be painted a neutral color in order not to be too conspicuous.

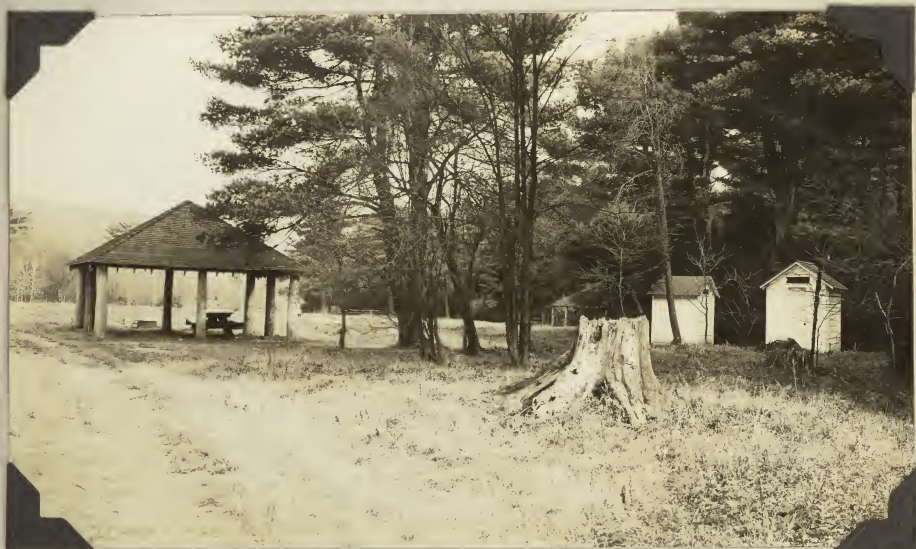
312300

Allegheny National Forest - Kelly Pines Forest Camp

General view of picnic ground area. Note the very conspicuous location in which the toilet buildings are placed. These buildings should have been stained or painted in some shade of brown, and a location which is not as conspicuous ought to be selected in which to construct these features.

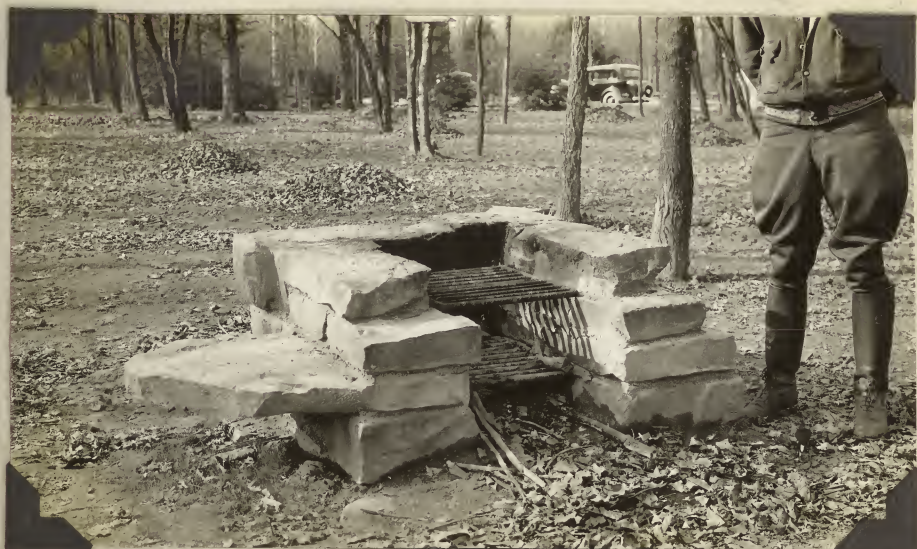
312311

Allegheny State Park - (In New York)

Detail of stone fireplace of a very interesting type. Note the arrangement of grates as shown in this photograph and photograph No. 143.

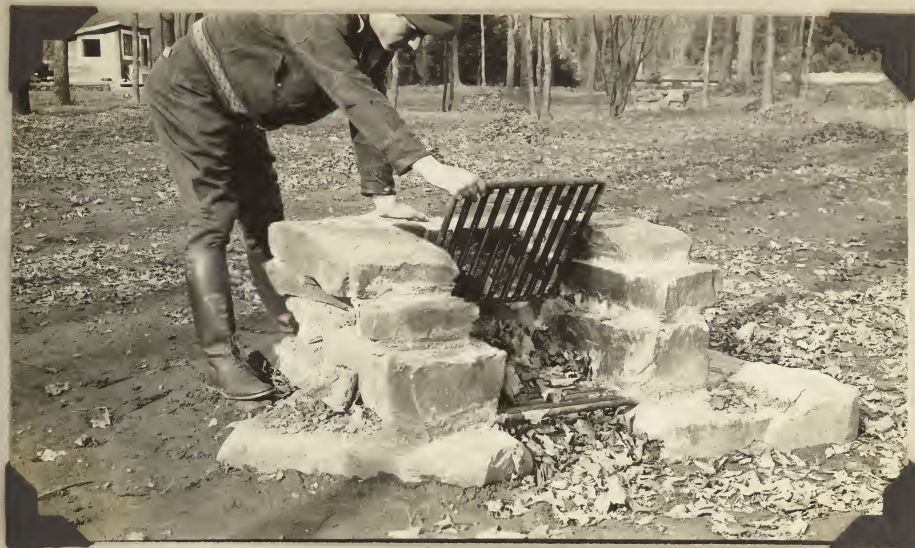
312312

Allegheny State Park - (In New York)

Detail of a typical fireplace used in some portions of this park area.

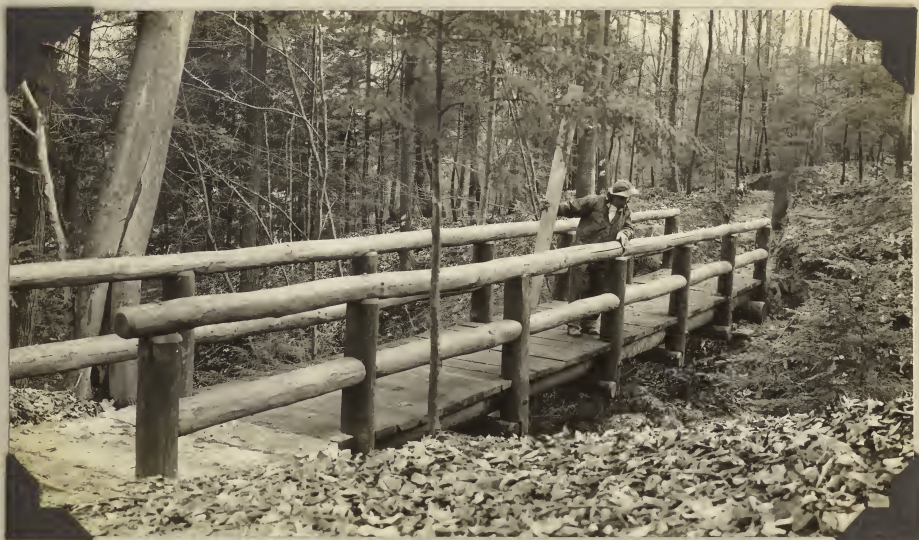
312318

Allegheny National Forest - Allegheny Forest Camp

General view of the footbridge extending across a small ravine. This footbridge is excellently designed and very appropriate for this location.

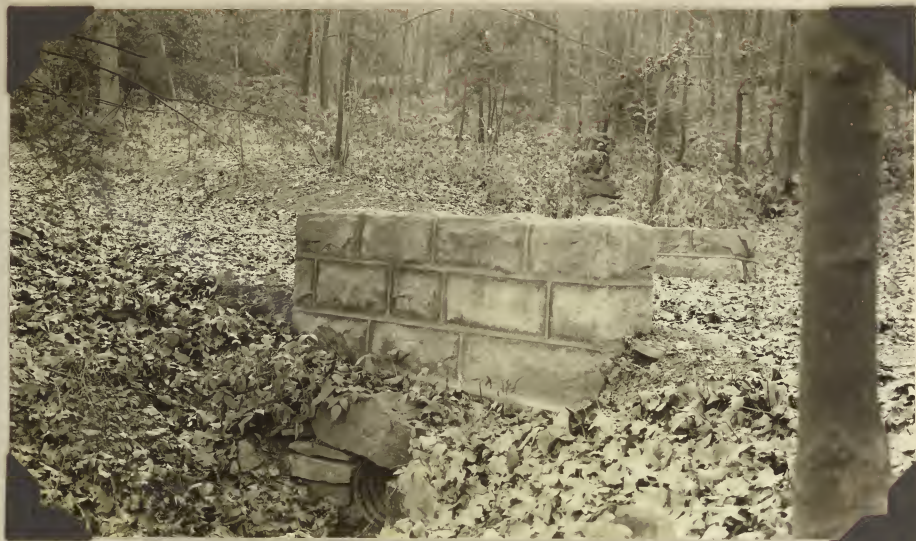
3/2 321

Allegheny National Forest - Allegheny Forest Camp

This type of stone masonry headwall, constructed some years ago, is not appropriate for a forest camp. It is not sufficiently informal in design.

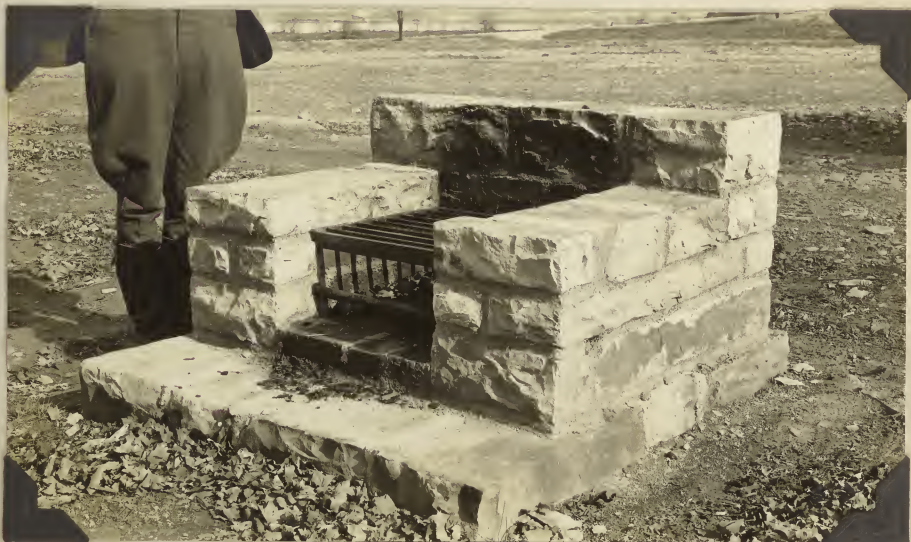
3/2 324

Allegheny State Park - (In New York)

Detail view of one of the fireplaces. The type of stone work in this fireplace is too formal and does not conform with the natural surroundings of a forest area.
